DS26401

Octal T1/E1/J1 Framer

REVISION A1 ERRATA

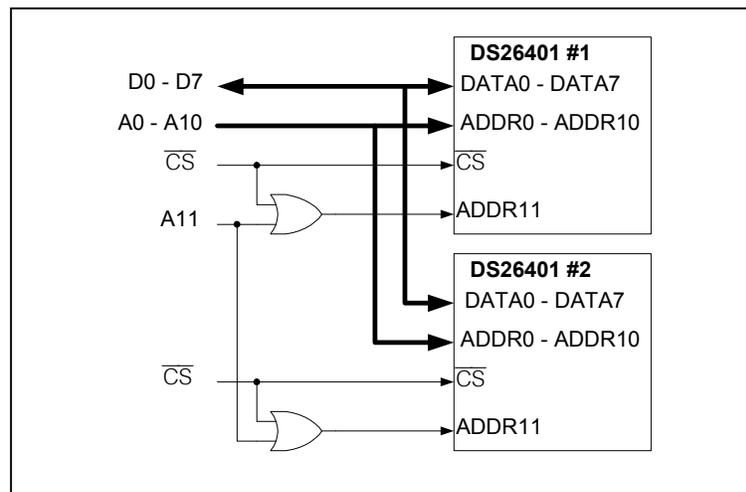
The Global Registers in address space 0x0F0-0x0FF are not gated with \overline{CS} . Write operations to other devices on the bus at these addresses 0x0F0 and 0x0F1 will affect the GCR1 and GCR2 registers. There are also unused registers in this space that must remain at 0x00 for proper operation.

OR the ADDR[11] input with \overline{CS} to ensure that ADDR[11] is a logical 1 when the DS26401 is not being accessed.
