ERRATA SHEET

DS26519

Revision A2 Errata

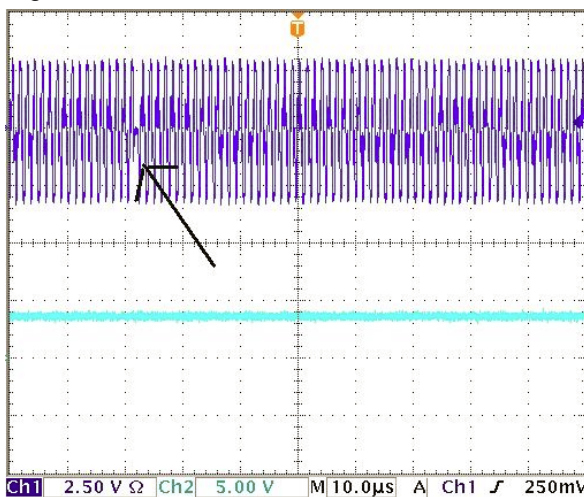
Figure 1

The TTIPn/TRINGn line drivers should be high impedance whenever TXENABLE is low. On rev A2 devices, the TTIPn/TRINGn line drivers are briefly enabled during power-up, even if TXENABLE is low. This may cause the inactive DS26519 in a Y-cable application to attenuate the transmit waveform of the active DS26519 and create a bit error, as seen in the figures below.

None.
