## ERRATA SHEET DS3112

### Revision D1 Errata

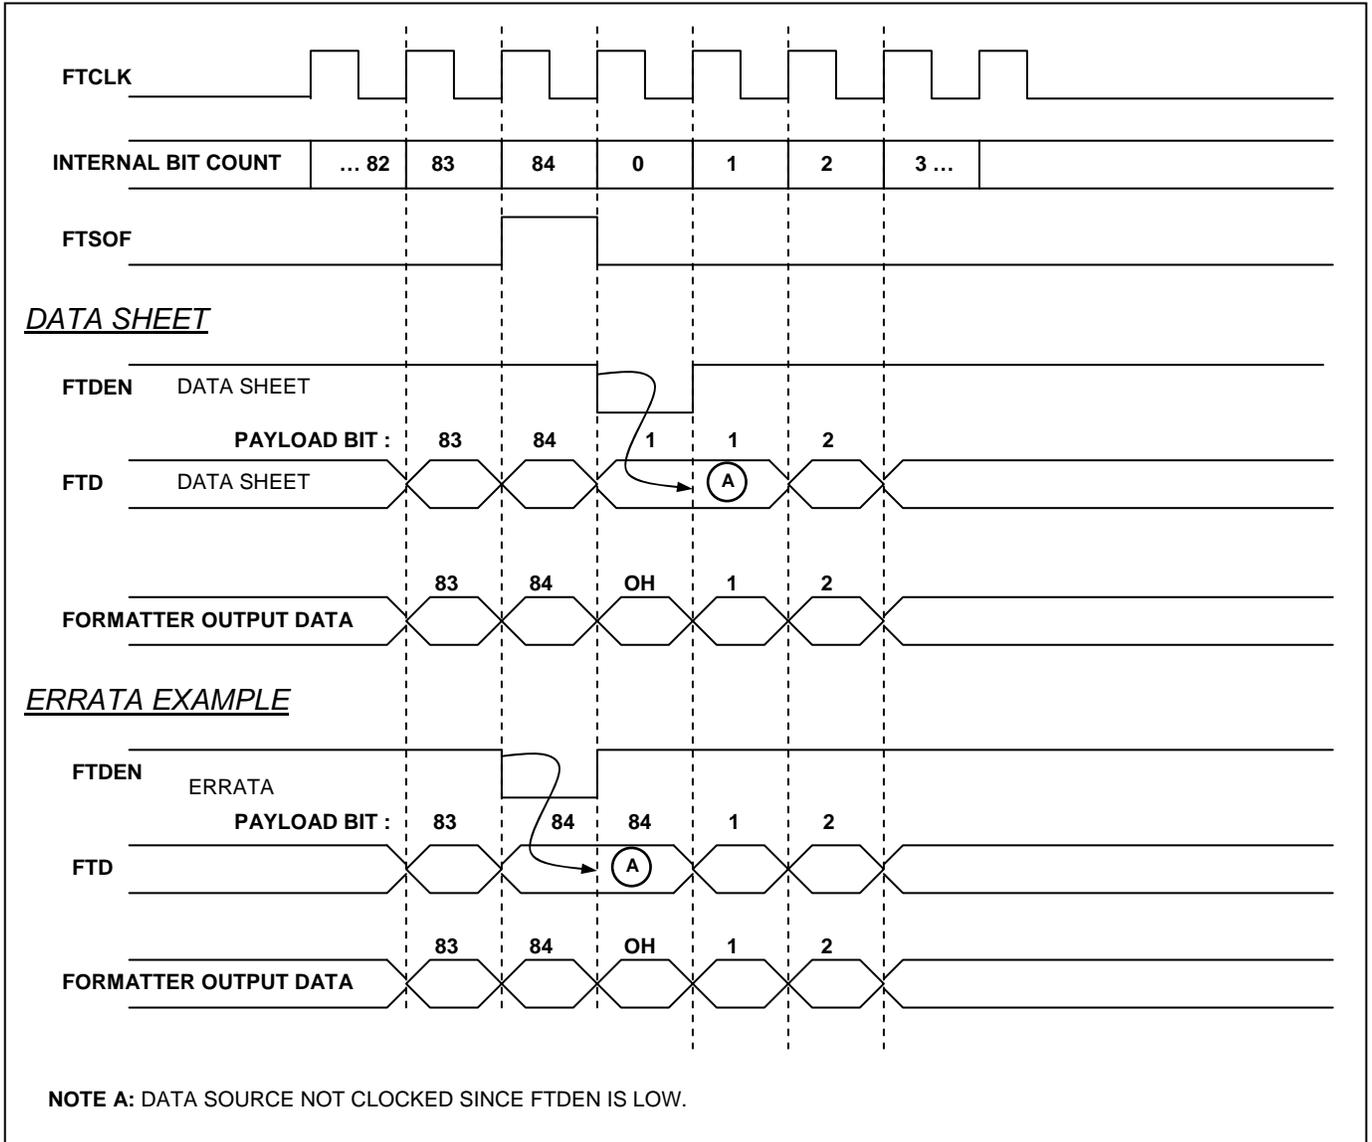
Figure 1. Timing Diagram

The FTDEN output pin (T3/E3 - Transmit Formatter Serial Data Enable) pulses one clock cycle earlier than specified in Figure 2.4A of the DS3112 data sheet. This occurs in T3 mode only. FTDEN is early for both data-enable and gapped-clock modes of operation. This only affects unchannelized T3 operation; channelized T3 and E3 are not affected.

This erratum has no effect on the output data stream. Figure 1 shows that whether FTDEN pulses per the data sheet or one cycle early, the formatter output data is the same. The overhead bit is properly inserted between payload bit 84 and payload bit 1. The example in Figure 1 depicts the DS3112 where FTDEN is configured as a data enable. The gapped clock case is identical.

Use an external flip-flop to delay the FTDEN signal one clock cycle.
