MAX32630 ERRATA SHEET

Revision A2 Errata

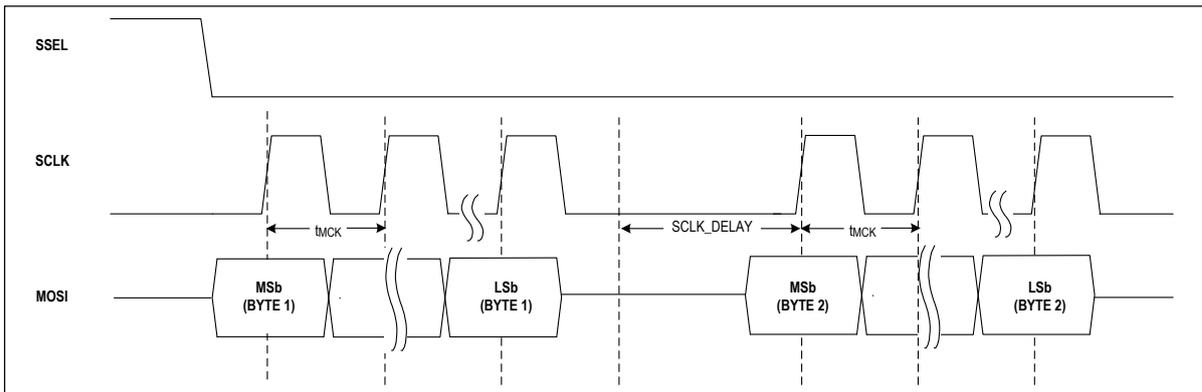
The SPI master remains low one or more SCLK cycles after transmitting 8 bits of data, resulting in an interbyte delay when transmitting back-to-back bytes. This erratum does not affect the integrity of the synchronous SPI bus because no data is clocked in or out by the SPI slave during the delay time SCLK is asserted low.

In single mode, the delay occurs after SDIO[0] has transmitted all 8 bits.

In dual mode, the delay occurs after SDIO[1:0] have each transmitted 4 bits.

In quad mode, the delay occurs after SDIO[3:0] have each transmitted 2 bits.

The length of the delay is a function of the SPI clock frequency as shown in the following table. The SPI master must be operated in sample mode with a maximum frequency of 24MHz.

Workaround:

None.
